Multifunctional tool extension fix

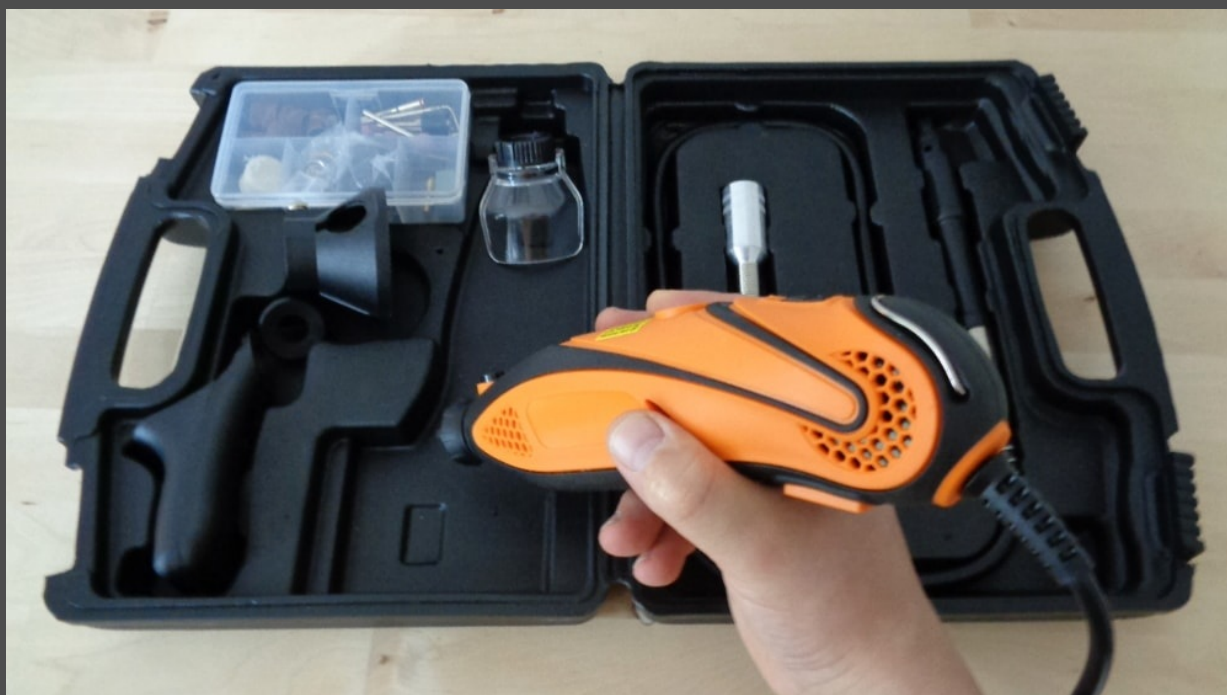
Two weeks ago I ordered a multifunctional tool online so that I could work on some projects faster. For example, I have many workpieces that need to be ground and that works by hand. It only takes twice as long and I still sand the details by hand because I pay a lot of attention to the details. However, I had tried the extension and either made a mistake when connecting or the suspension

(an infusion stand) had a bad effect on the function. Perhaps the product was also only poorly processed. When I tried it out, it broke and I had to repair it.

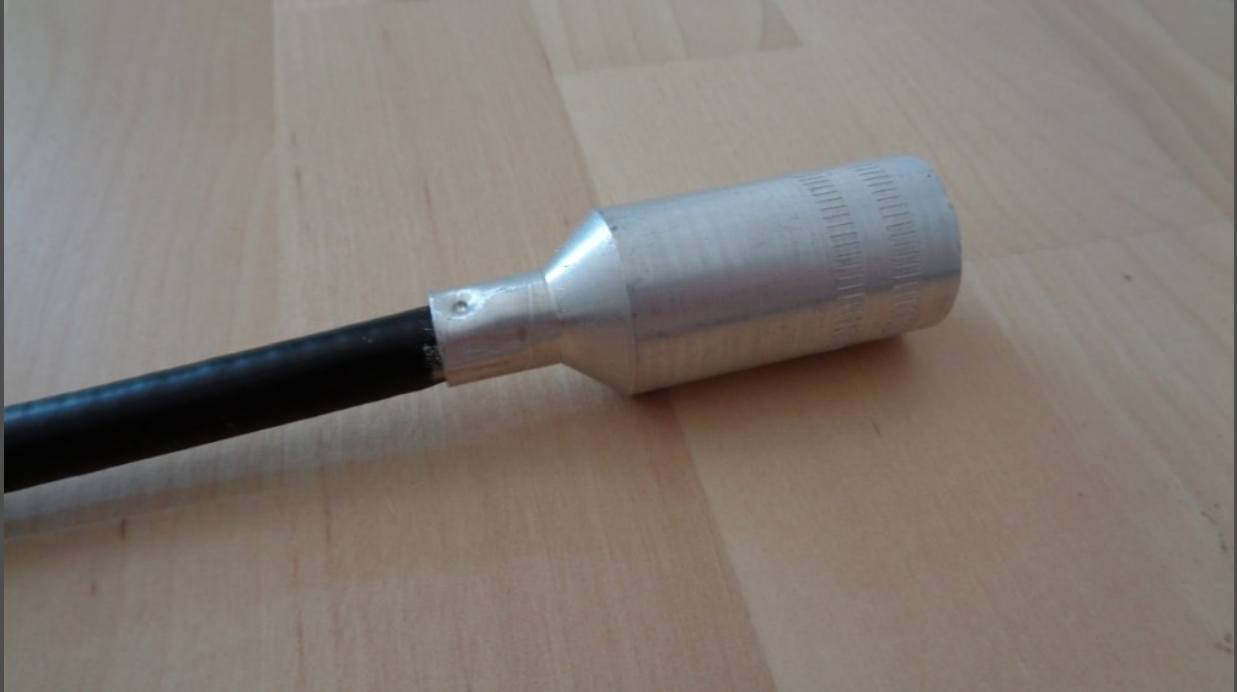
In the first step we pull the spiral spring away from the end to be repaired. Therefore we pull the spring with a strong jerk and try not to bend it too much. We remove the aluminium screw cap. Also here one needs sufficient power, although in my opinion the construction unit could be installed more firmly.

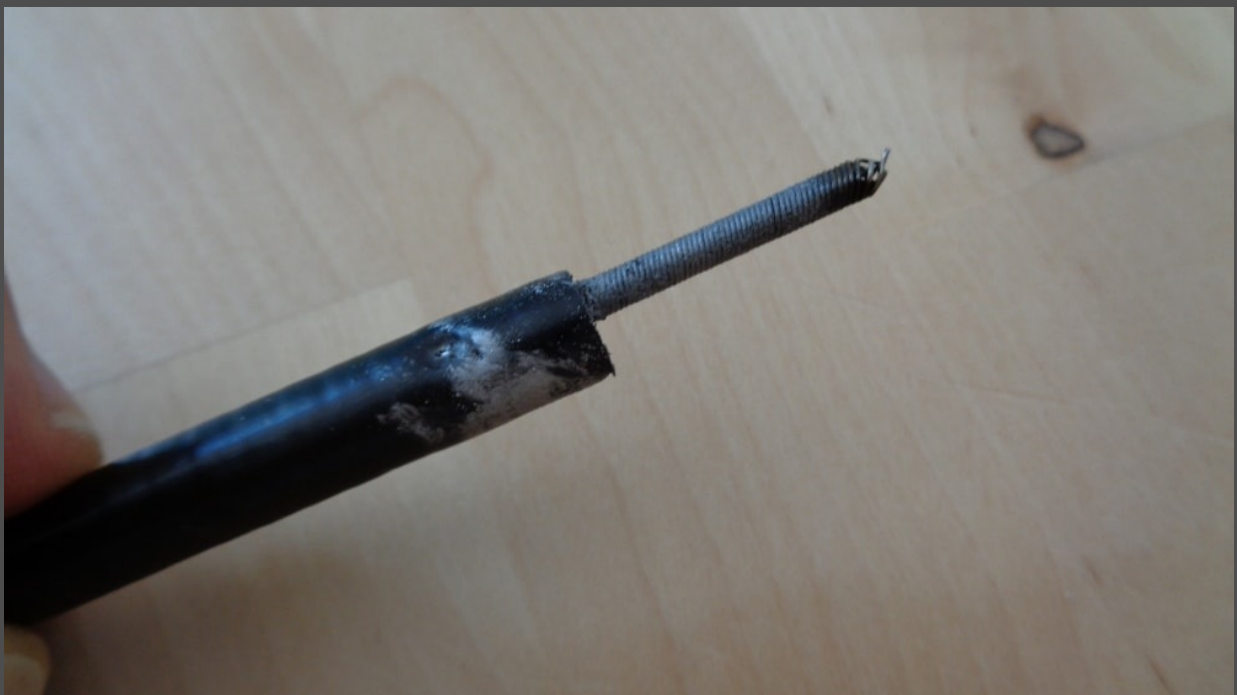
We can see exactly where the steel wire twisted, which in turn led to the actual breakage. This wire is screwed to the socket of the multifunction tool and then passes the rotation to the module at the other end of the extension. This makes it possible to work finer and more accurately, as you do not have to hold the heavy machine in your hand.

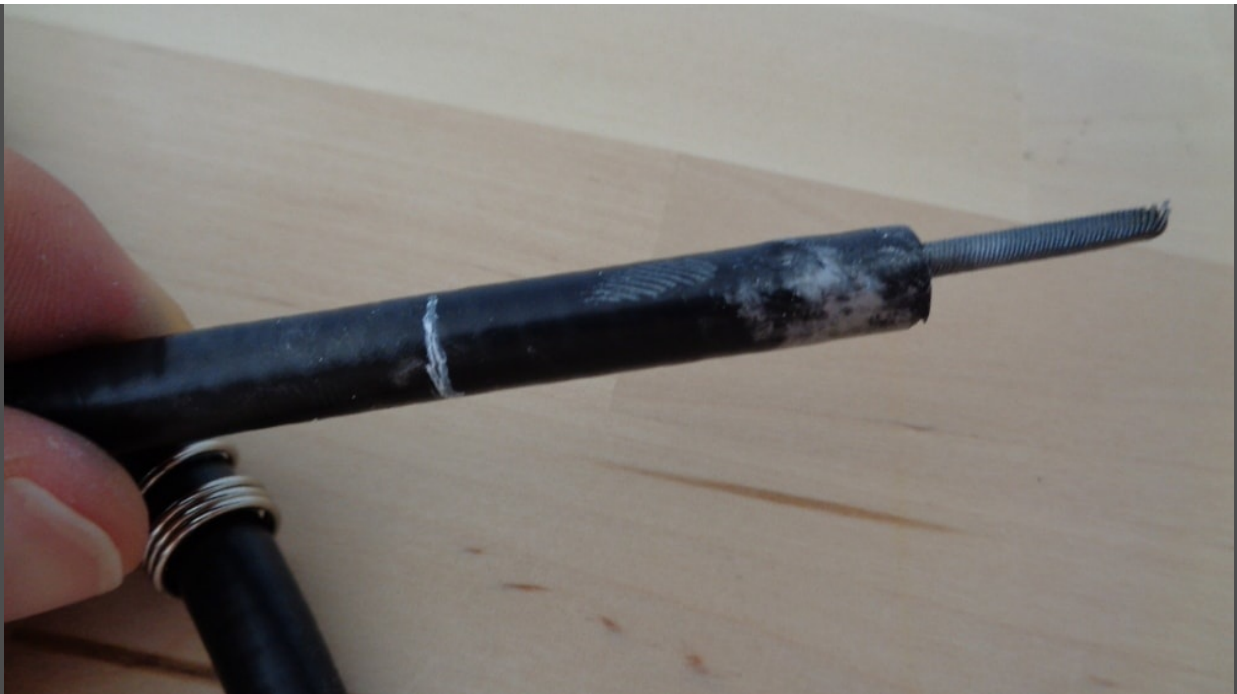
We now use the aluminium screw cap to draw the length. You should always adhere to the often-vaunted rule: Better too much than too little. If we leave more of the steel cable over and it should be too much when clamping, we can still cut off a piece with the pliers. We hold the aluminium piece to the rubber hose and mark it with a white (or another colour) marker. At this point we pinch a hole with the pincers and slowly separate one end of the hose from the main part.

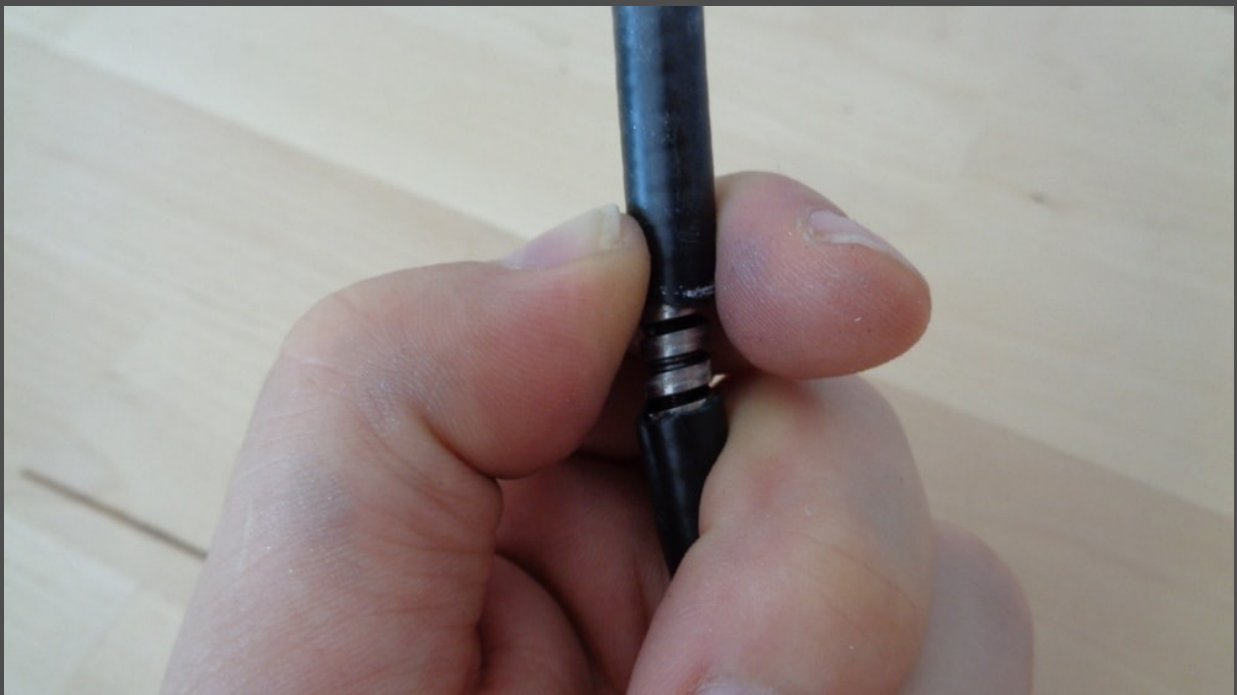
Under the protective foil is another metal spiral. This gives the extension stability and prevents it from twisting into itself. I just wanted to cut it with the little side cutter and broke it. I thought the tool was more stable. At this point it is best to work with a metal saw. Since the spiral is flexible on its own, you should work carefully to avoid slipping and sawing your hand by mistake.

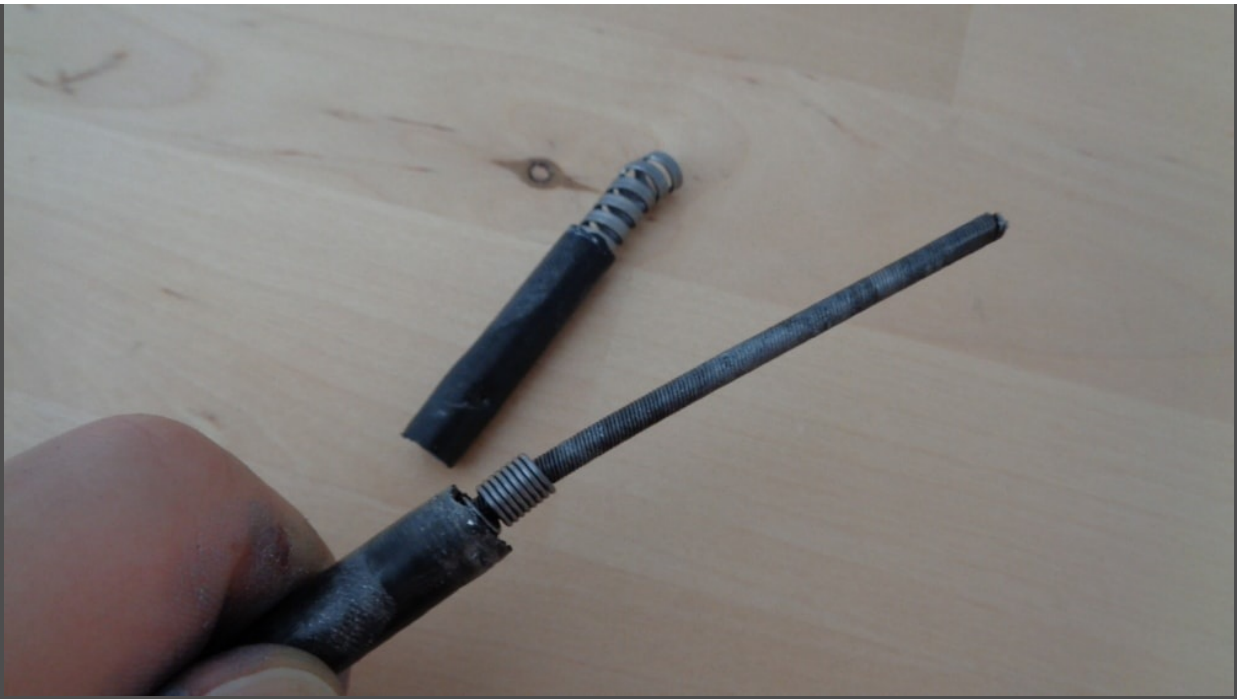
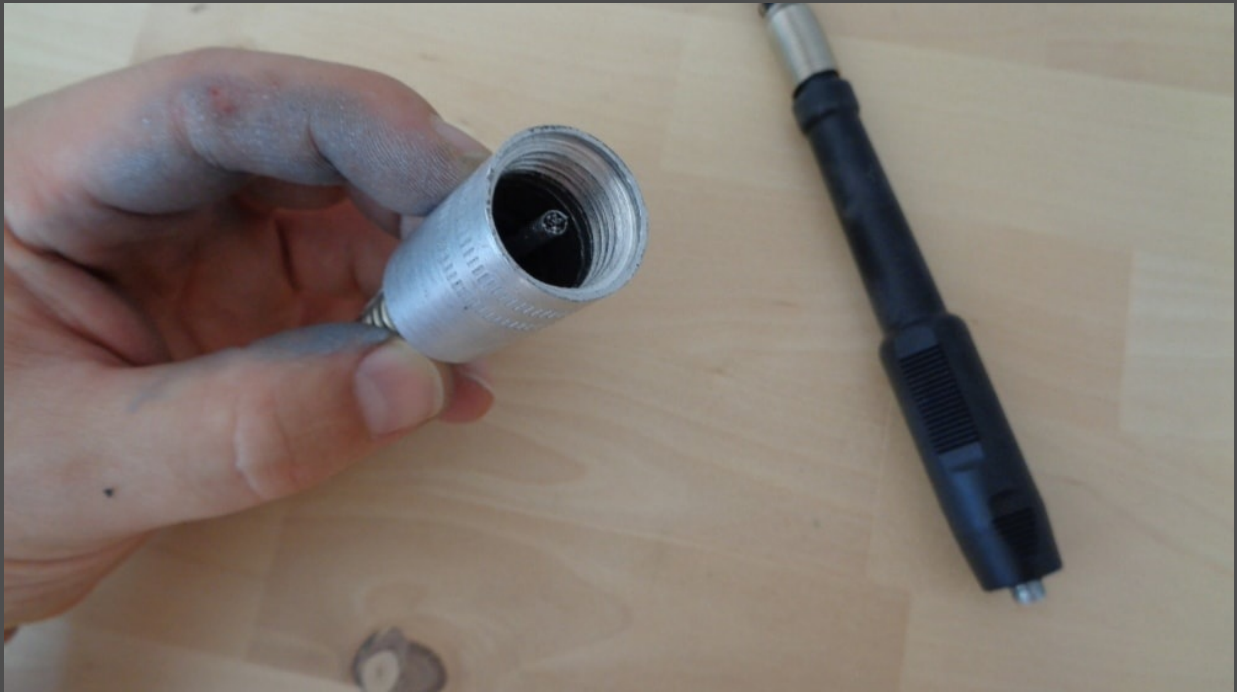
Here we see the end after we have removed all the superfluous protective cover. Now all components are put on again. So first the component made of aluminium. If this does not immediately go over the plastic, it can be scraped off a little with a carpet knife. Then we pull the outer metal spiral over again and shorten the metal part to the appropriate length. We test this with a not so fast speed and try all levels from 1-6.
